Tub Thumping

Wider wheel housings for a '55 Chevy

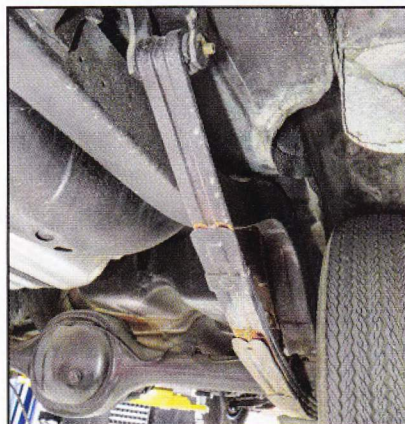
1. This shot of the stock leaf spring and wheelwell clearly shows how the springs mount outside the chassis rails.

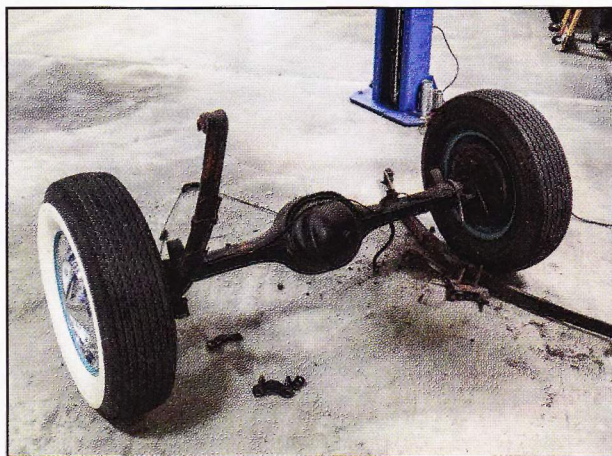
2. The first order of business was to remove the original rear end and springs.

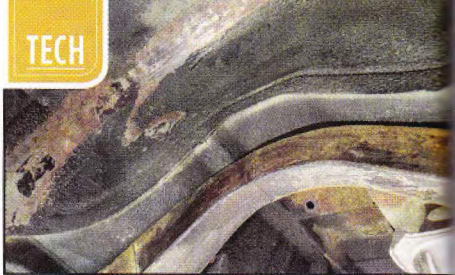
3. Installing the new wider housings will increase the usable space by moving the inner wall of the wheelhousing flush with the frame.

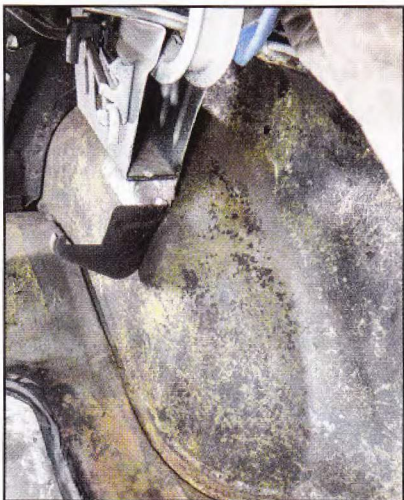
4. The stock inner wheelhousing will be removed, but the tulip panel/trunk hinge brace must also be modified to accept the wider housings.

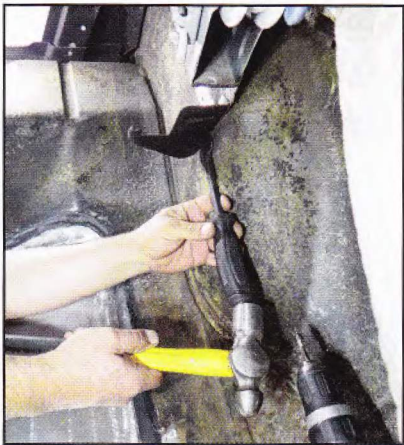
5. The spot-welds on the brace were drilled out at their lowest attachment points, a chisel used to free them. They can also be severed with a cut-off wheel directly above the spot-welds, the shortened brace welded onto the new housing once installed.

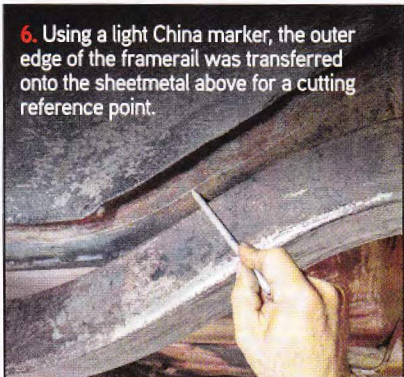
6. Using a light China marker, the outer edge of the framerail was transferred onto the sheetmetal above for a cutting reference point.

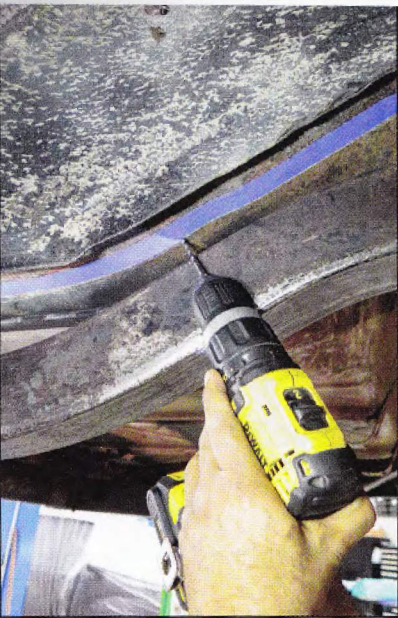
7. The line was then taped and a series of 1/8-inch holes drilled to transfer the cut reference line to the inside of the wheelwell.

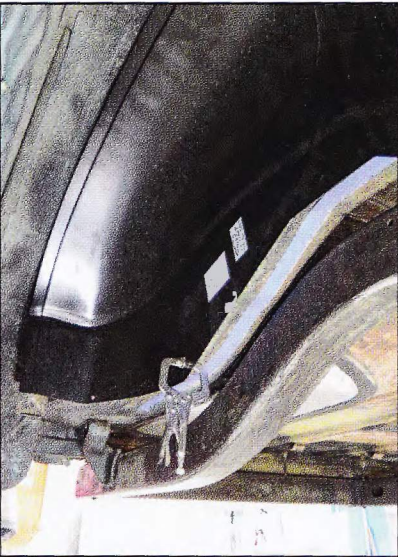
8. The new wheel housing was mocked in place ...

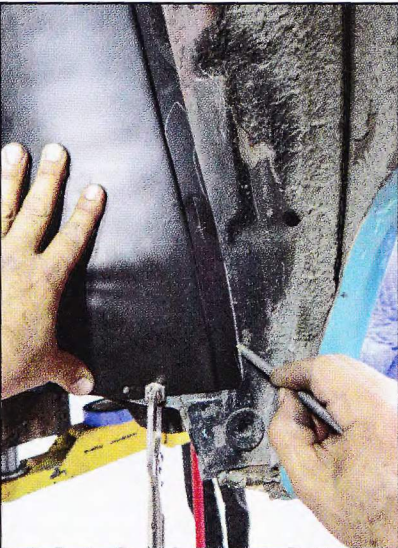
9. ... and the outer profile, toward the fender lip, was transferred onto the original wheelwell.

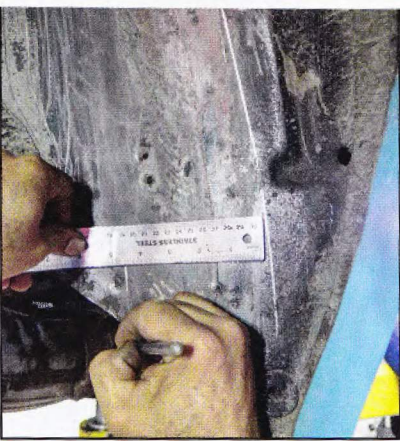
10. From there, a "rough" cut line was established, factoring in the added width of the new wheel housing minus the overlap.

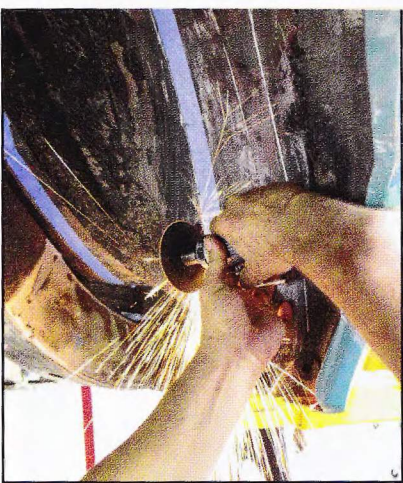
11. The cuts were started with a cut-off wheel ...

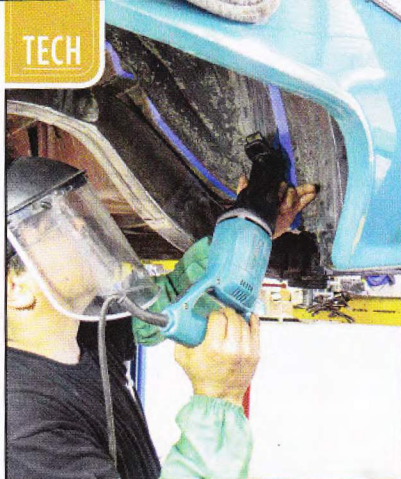
12. ... then switching to a Sawzall.

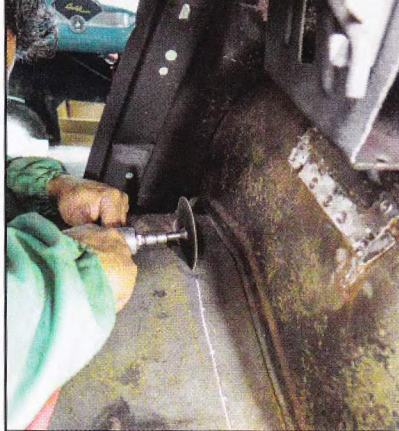
13. The same process was repeated on a line marked between the previously drilled holes on the trunk floor.

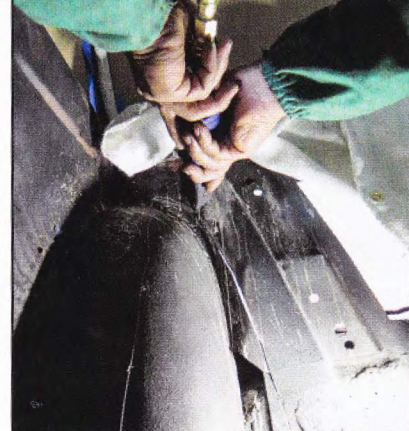
14. In the rear seat brace area an air saw was used, owing to restricted access.

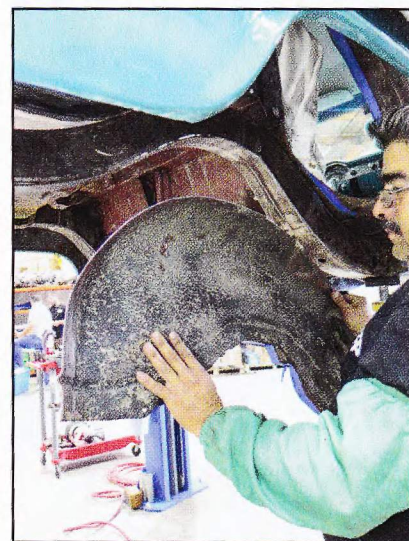
15. The original inner wheelwell was then removed in one piece.

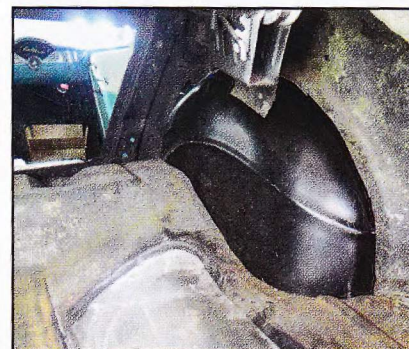
16. Since the opening was cut undersize, the wider wheel housing was mocked in place to determine further trimming.

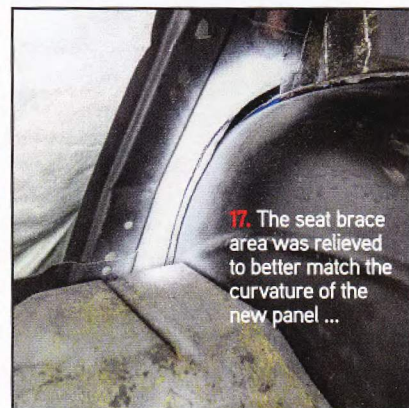
17. The seat brace area was relieved to better match the curvature of the new panel ...

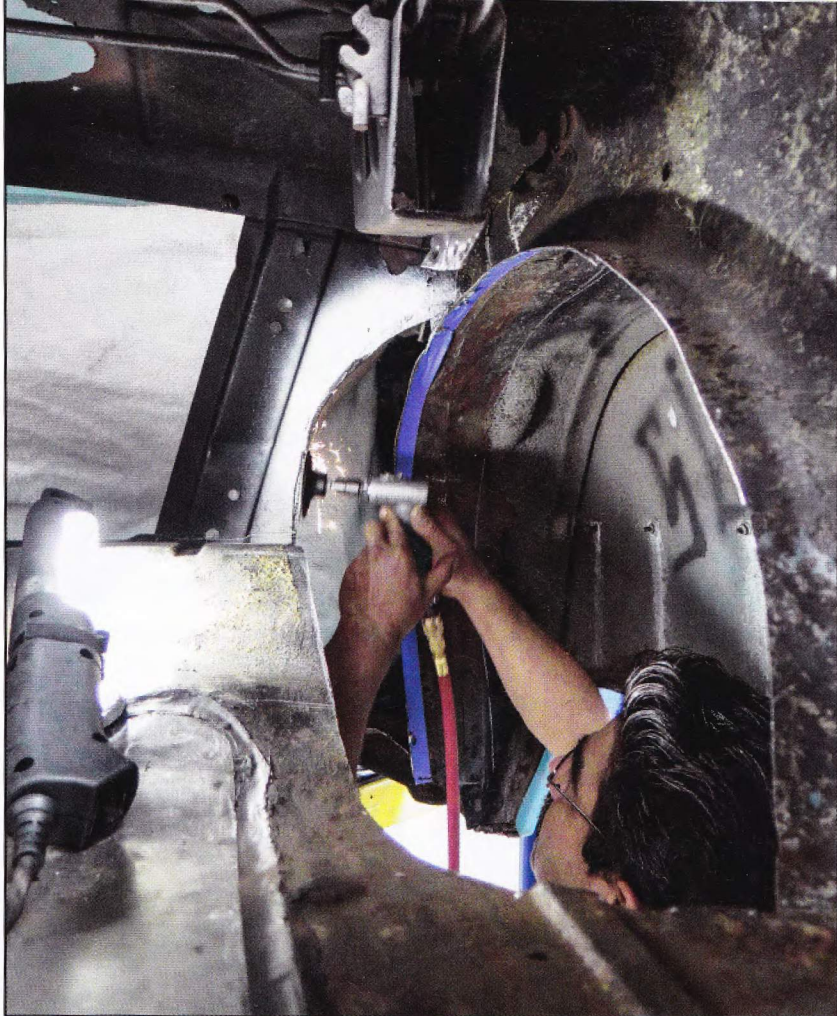
18. ... then dressed with a small air grinder.

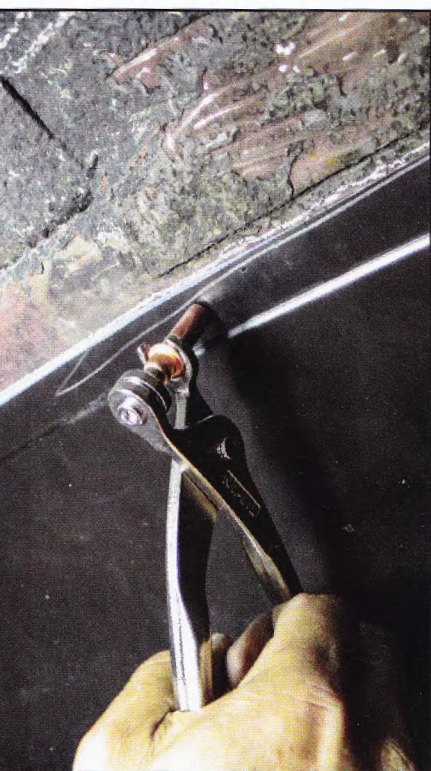
19. Once happy with the fit of the new panel, it was temporarily attached through the overlap using Cleco fasteners.

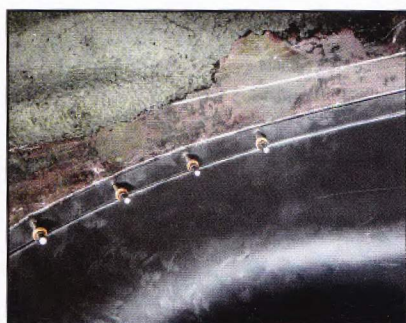
20. This process was repeated over the length of the new panel.

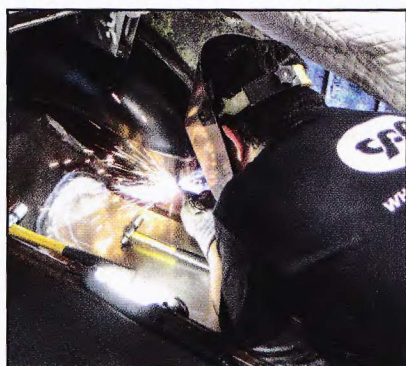
21. With the surrounding sheetmetal prepped, the housing was tack-welded in place. Its black coating is a weld-through primer.

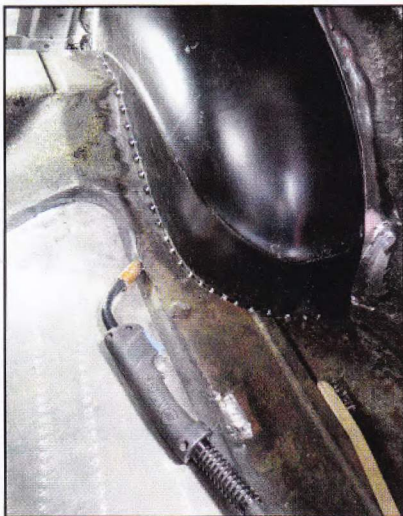
22. Tack welds at regular intervals would later be seam welded.

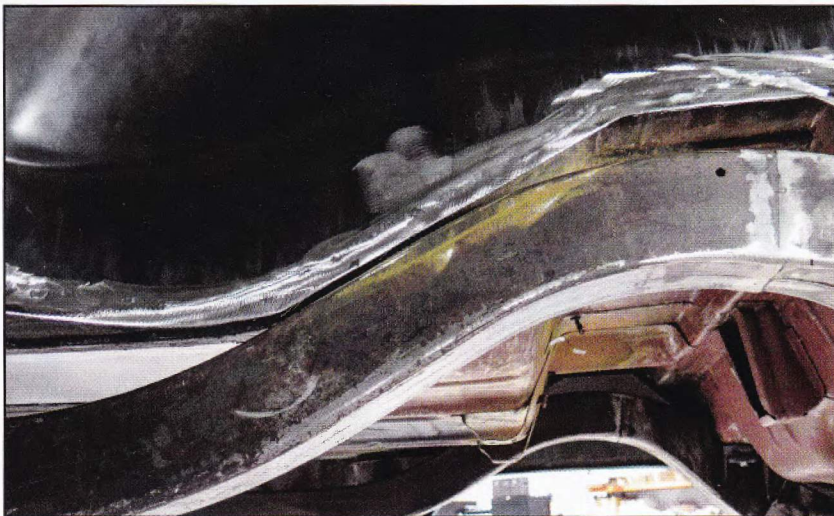
23. The lower edge of the new housing was shaped to match the contour of the framerail, then deburred.

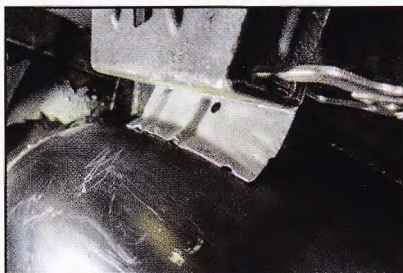
24. The trunk hinge brace, shown cut at the old spot-weld points, was recontoured to fit the shape of the new panel before being welded in place.

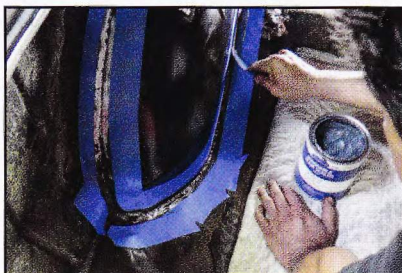
25. Once the panel was finish welded all round and the Cleco holes welded shut, Eastwood seam sealer was applied over the joints. The masking tape makes for neat edges to the sealer once it is brushed on.

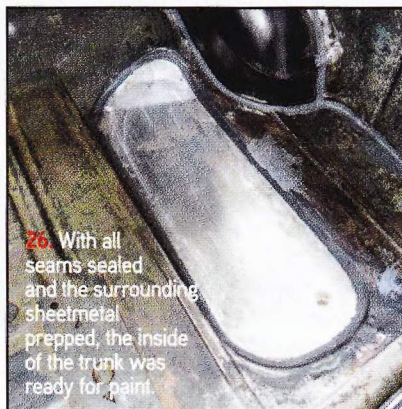
26. With all seams sealed and the surrounding sheetmetal prepped, the inside of the trunk was ready for paint.

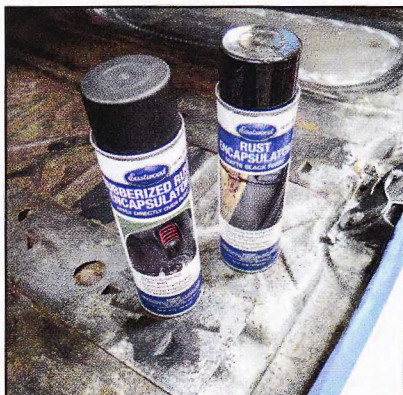
27. Eastwood Rust Encapsulator was used; the regular product used inside, and the rubberized version used on the underside, as it acts as an undercoating.

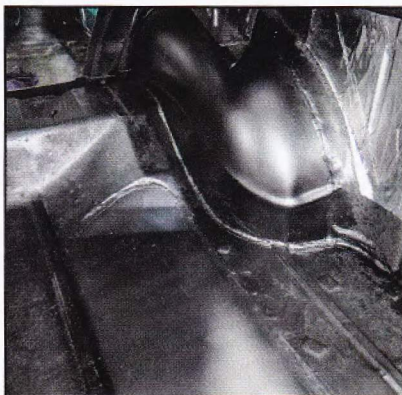
28. The Rust Encapsulator was applied to the wheelwells, floor, and inner quarter-panels.

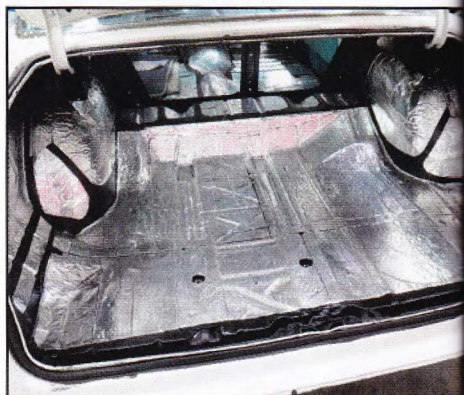
29. Hushmat was then installed on all trunk surfaces, as well as the underside of the trunklid itself.

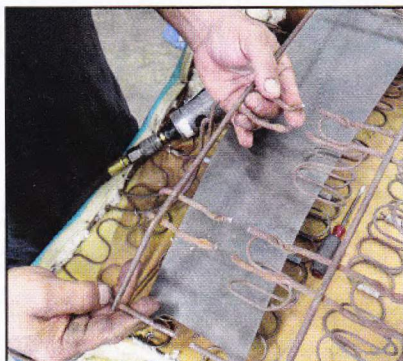
30. Lastly, the seat base and back frame structures need slight modification in order to fit the contours of the widened wheelwells.

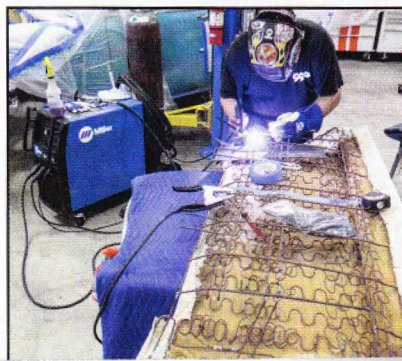
31. The seat mods can be done, if care is taken, without having to completely remove the upholstery and padding.

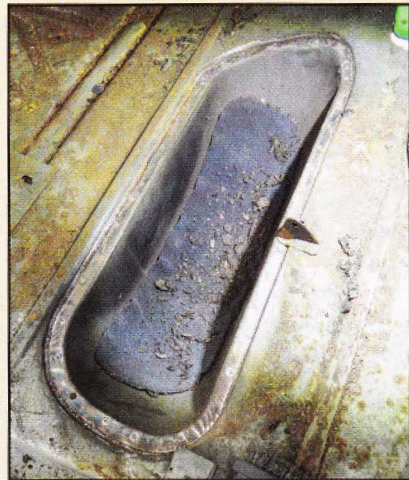
While this spare tirewell is in good shape, this is a common water trap, and therefore is rust prone. It's not unusual to see the entire bottom of the well missing. The perimeter was cleaned with a wire brush to reveal the welds.

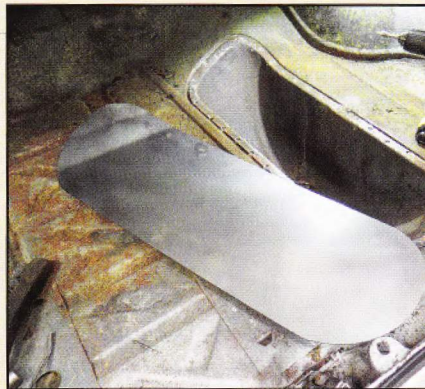
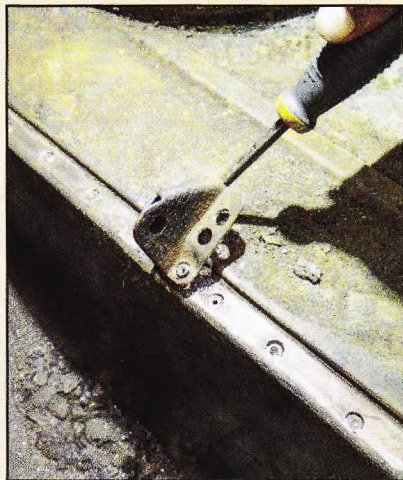
This bracket locates the spare tire-retaining strap. Its spot welds were drilled out along with those around the perimeter of the well.

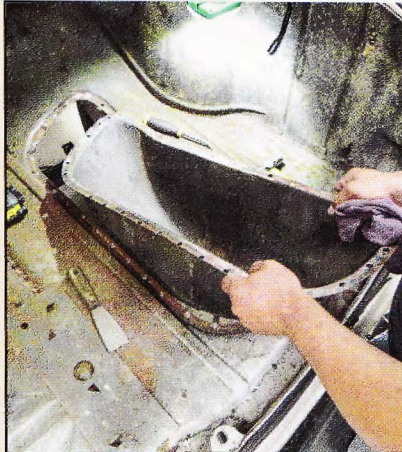
Once all the spot welds were drilled out, the wheelwell was removed.

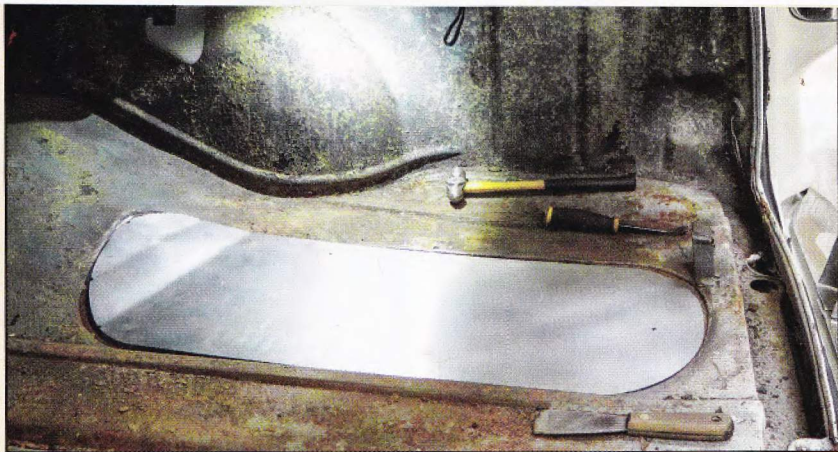
This simple, 18-gauge filler panel was cut to size and bent to shape at its forward edge, then checked for fit one final time.

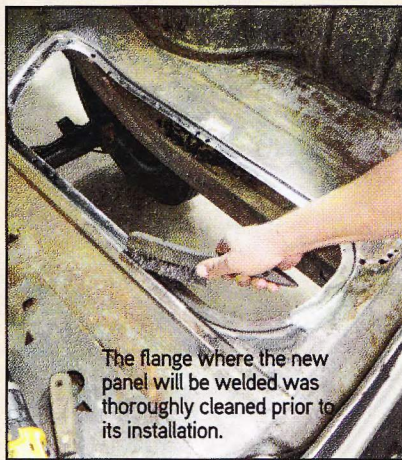
The flange where the new panel will be welded was thoroughly cleaned prior to its installation.

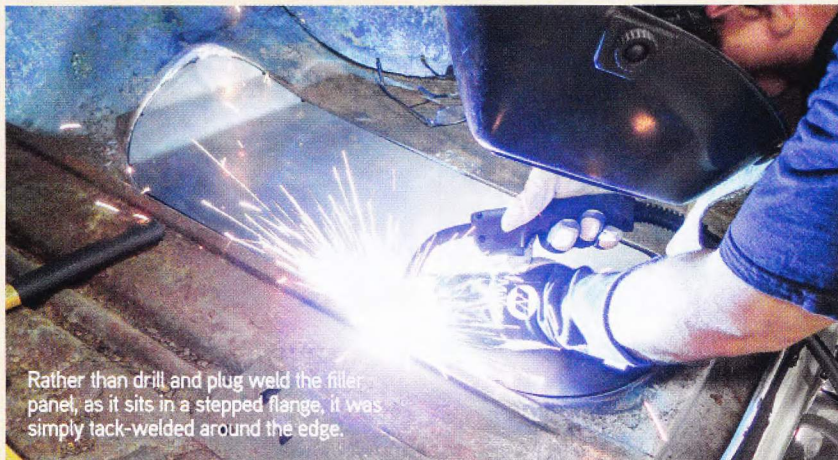
Rather than drill and plug weld the filler panel, as it sits in a stepped flange, it was simply tack-welded around the edge.

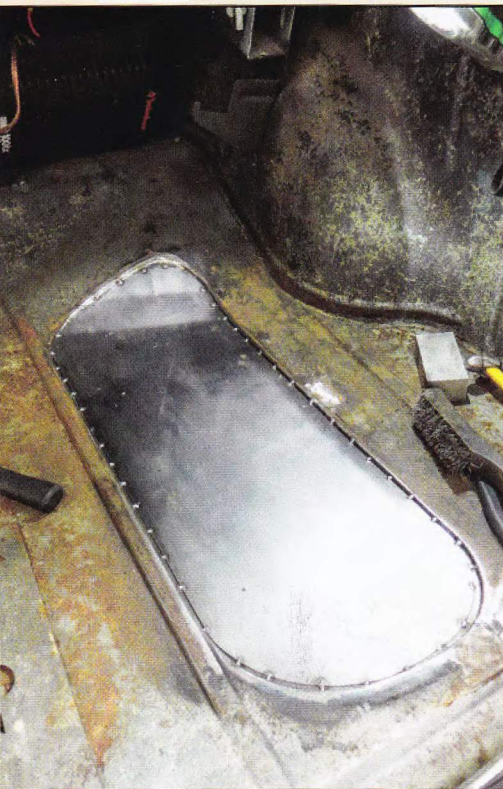
The panel tack-welded in place. It was further welded in short sections between the tacks.

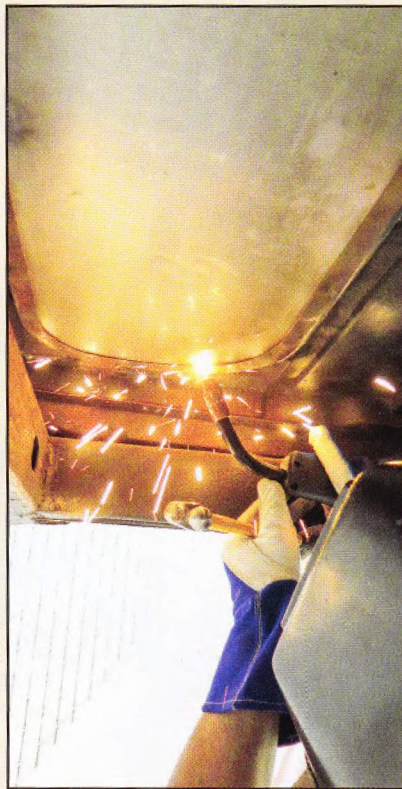
The edge was also welded on the underside in sections.

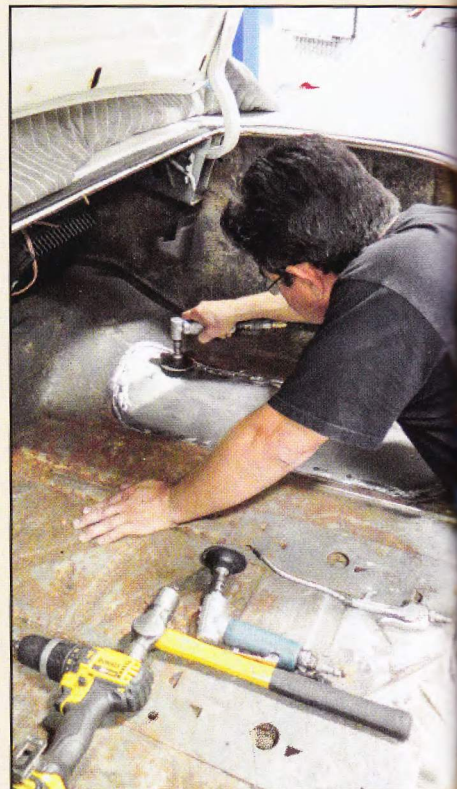
Prior to finishing, the welds were dressed with an air grinder.

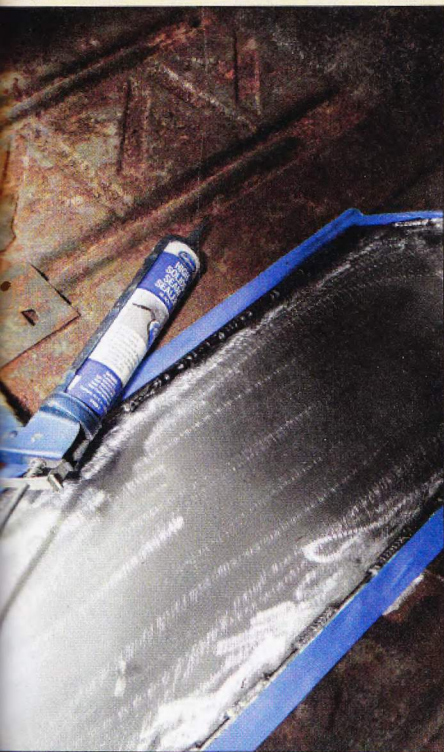
Eastwood high solid seam sealer was used to seal the perimeter. Note the short sections of weld rather than just tacks. The sealer will prevent moisture and rust in the joint.

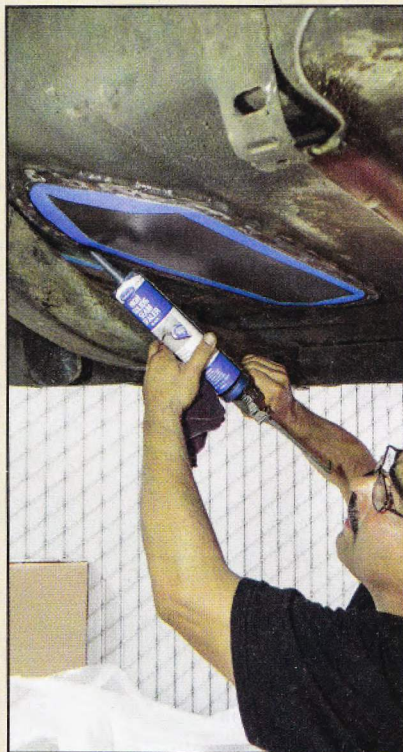
The underside was also sealed. Masking tape is used so that once the sealer is smoothed, rather than left as a bead, it will have a neat uniform edge.

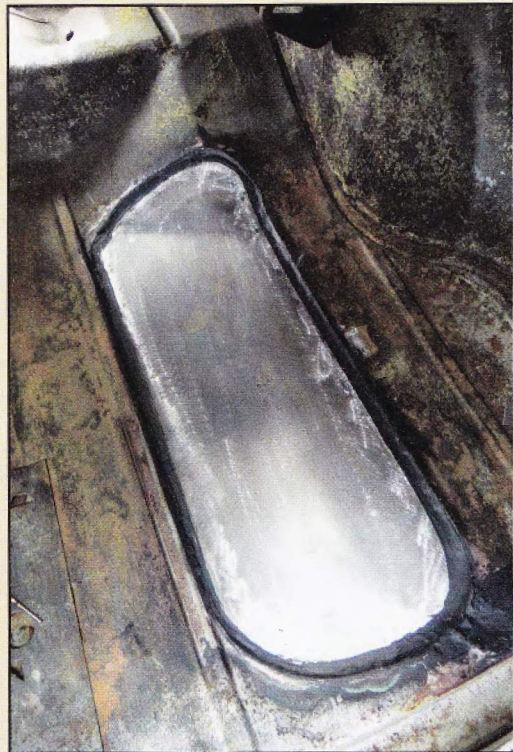
The finished filler panel, with a neatly sealed joint, ready for final finishing.
