Installing a CPP Steering Box on A Tri-Five Chevy

By Tim Bernsau

Making the upgrade to power steering with a rebuilt GM 605 box is a common project for Tri-Five Chevy owners. These popular steering boxes have become synonymous with Chevy power steering, are a great choice, and are available in rebuilt form from all kinds of manufacturers-but now there's something better.

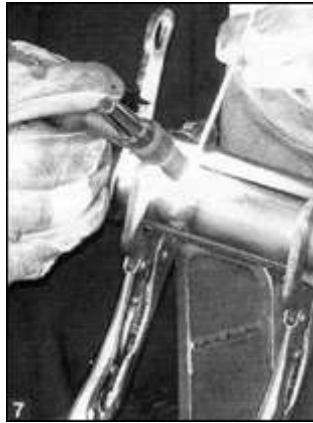
4. In order to work with the 500 Series box, which is longer, the stock steering column shift tube and mast tube have to be cut. Jeff measured and determined that a 3 1/4-inch section

would need to be removed from the shift tube and mast tube.
