# 605 UPGRADE

## THE NEW ERA OF 605 GEARBOXES

'60 Impala had several problems with the old first-generation 605 gearbox. Once the seals are worn, they tend to leak fluid and give you too much unwanted play, so we decided to upgrade the complete system using CPP's brand new '58-'64 Impala gearbox. These gearboxes are brand new and are designed for the Impala. With all new internal gears, these boxes will give your car the amenities of a newer car without having to use a junkyard remanufactured gearbox.

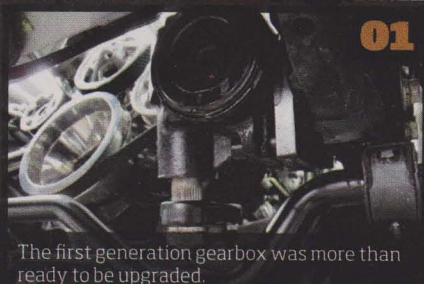
The first generation gearbox was more than ready to be upgraded.

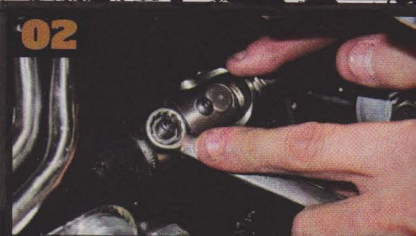
The universal joints were loosened to remove the steering shaft.

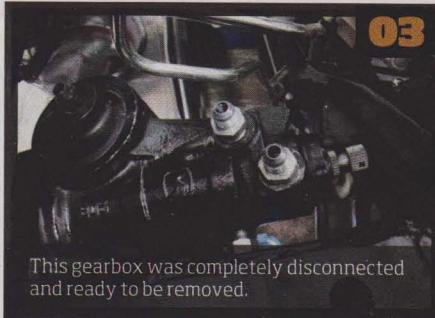
This gearbox was completely disconnected and ready to be removed.

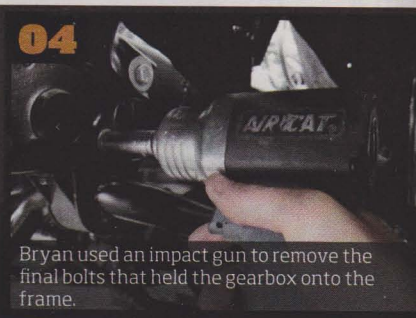
Bryan used an impact gun to remove the final bolts that held the gearbox onto the frame.

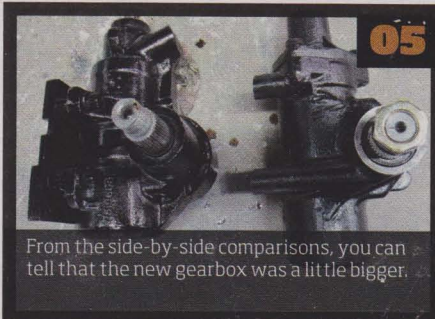
From the side-by-side comparisons, you can tell that the new gearbox was a little bigger.

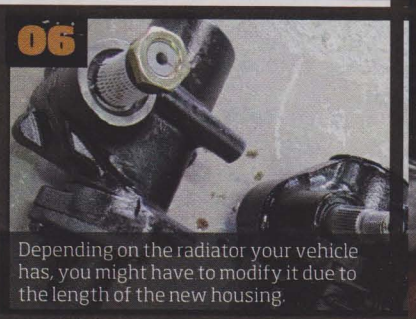
Depending on the radiator your vehicle has, you might have to modify it due to the length of the new housing.

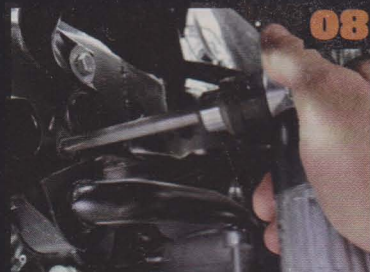
08

**8.** The 3/8 holes were drilled out with a 7/16 drill bit.

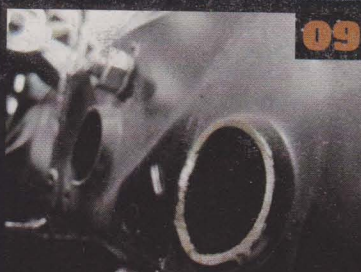
09

**9.** The old gearbox required you to grind down the side of the frame, so that it could be bolted on.

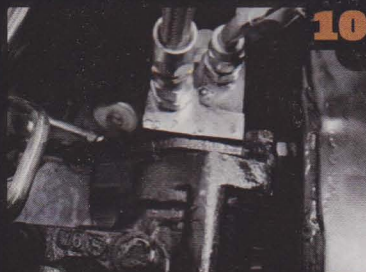
10

**10.** You can see the angle on the new gearbox. This was left this way in case you wanted to use a rag joint. With the angle, the pitch of the gearbox won't rip the rag joint.

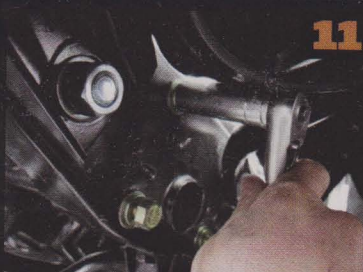
11

**11.** Since we didn't want to strip the bolts, the box was bolted on by hand.

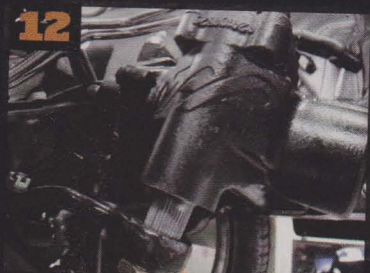
12

**12.** The stock pitman arm will bolt right up.

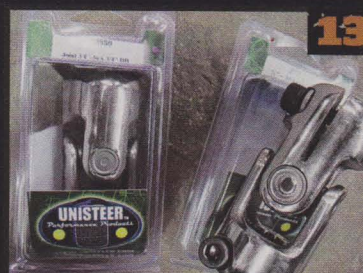
13

**13.** To make sure that our steering column was safe, we changed the universal joints to these UniSteer steering couplers.

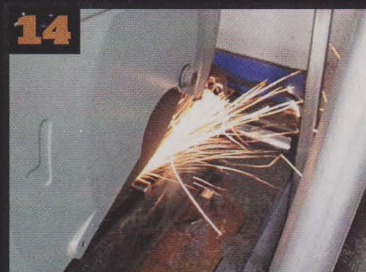
14

**14.** The Double D shaft was measured and cut to size.

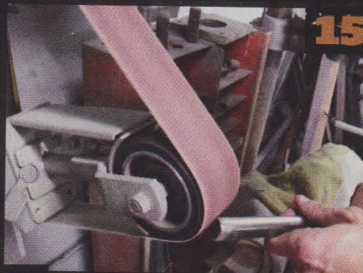
15

**15.** The edges were taken down on the grinder.

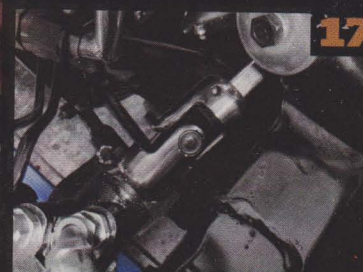
17

**17.** The steering couplers were tightened, keeping everything lined up.
